Righting the Costa Concordia Isola del Giglio, Tuscany, Italy

By Tiberio Minotti, Trevi and Vincent Jue, Soilmec North America

The Project: A Solid Foundation

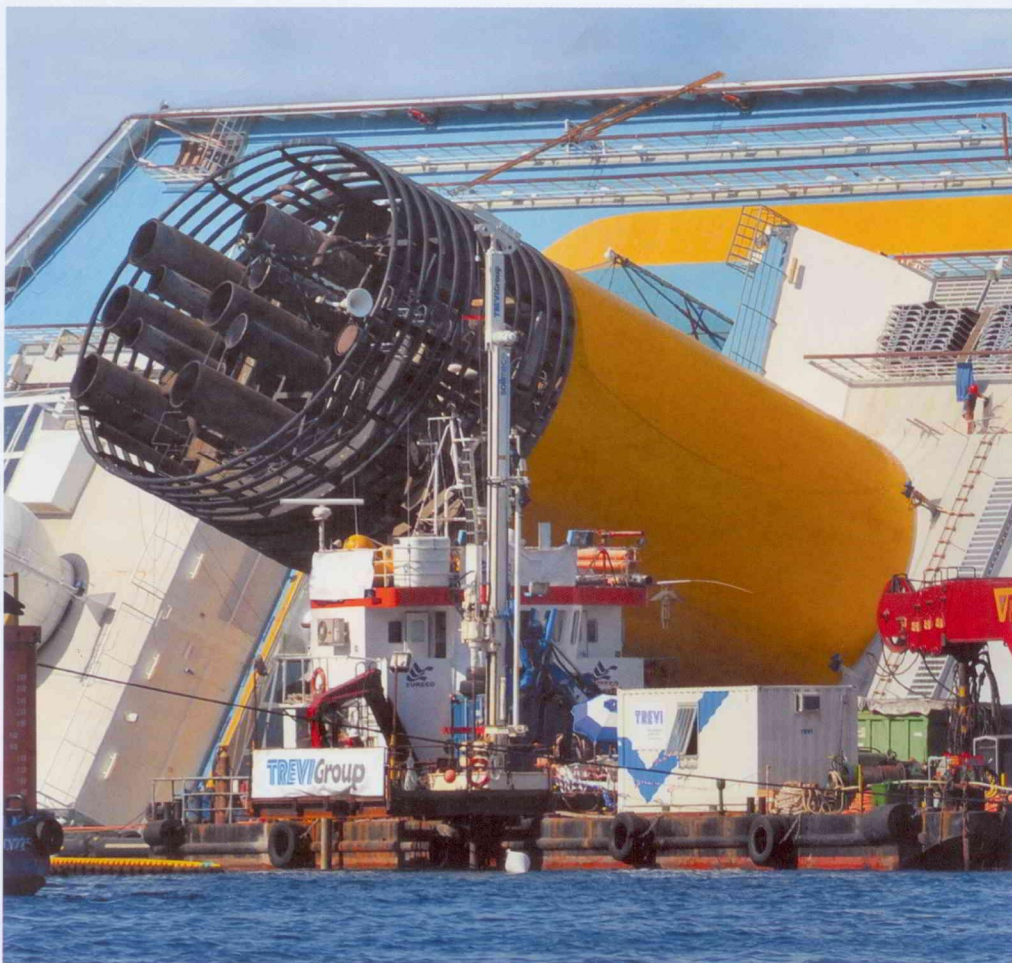
RCT worked off a barge-mounted Soilmec SM-20 drilling rig placed along side the ship's hull.

Trevi's RCT Srl division performed soil and rock testing to provide designers and other participants with a greater understanding of the geologic conditions. RCT carried out this work using a barge-mounted Soilmec SM-20 drilling rig, with a weight of about

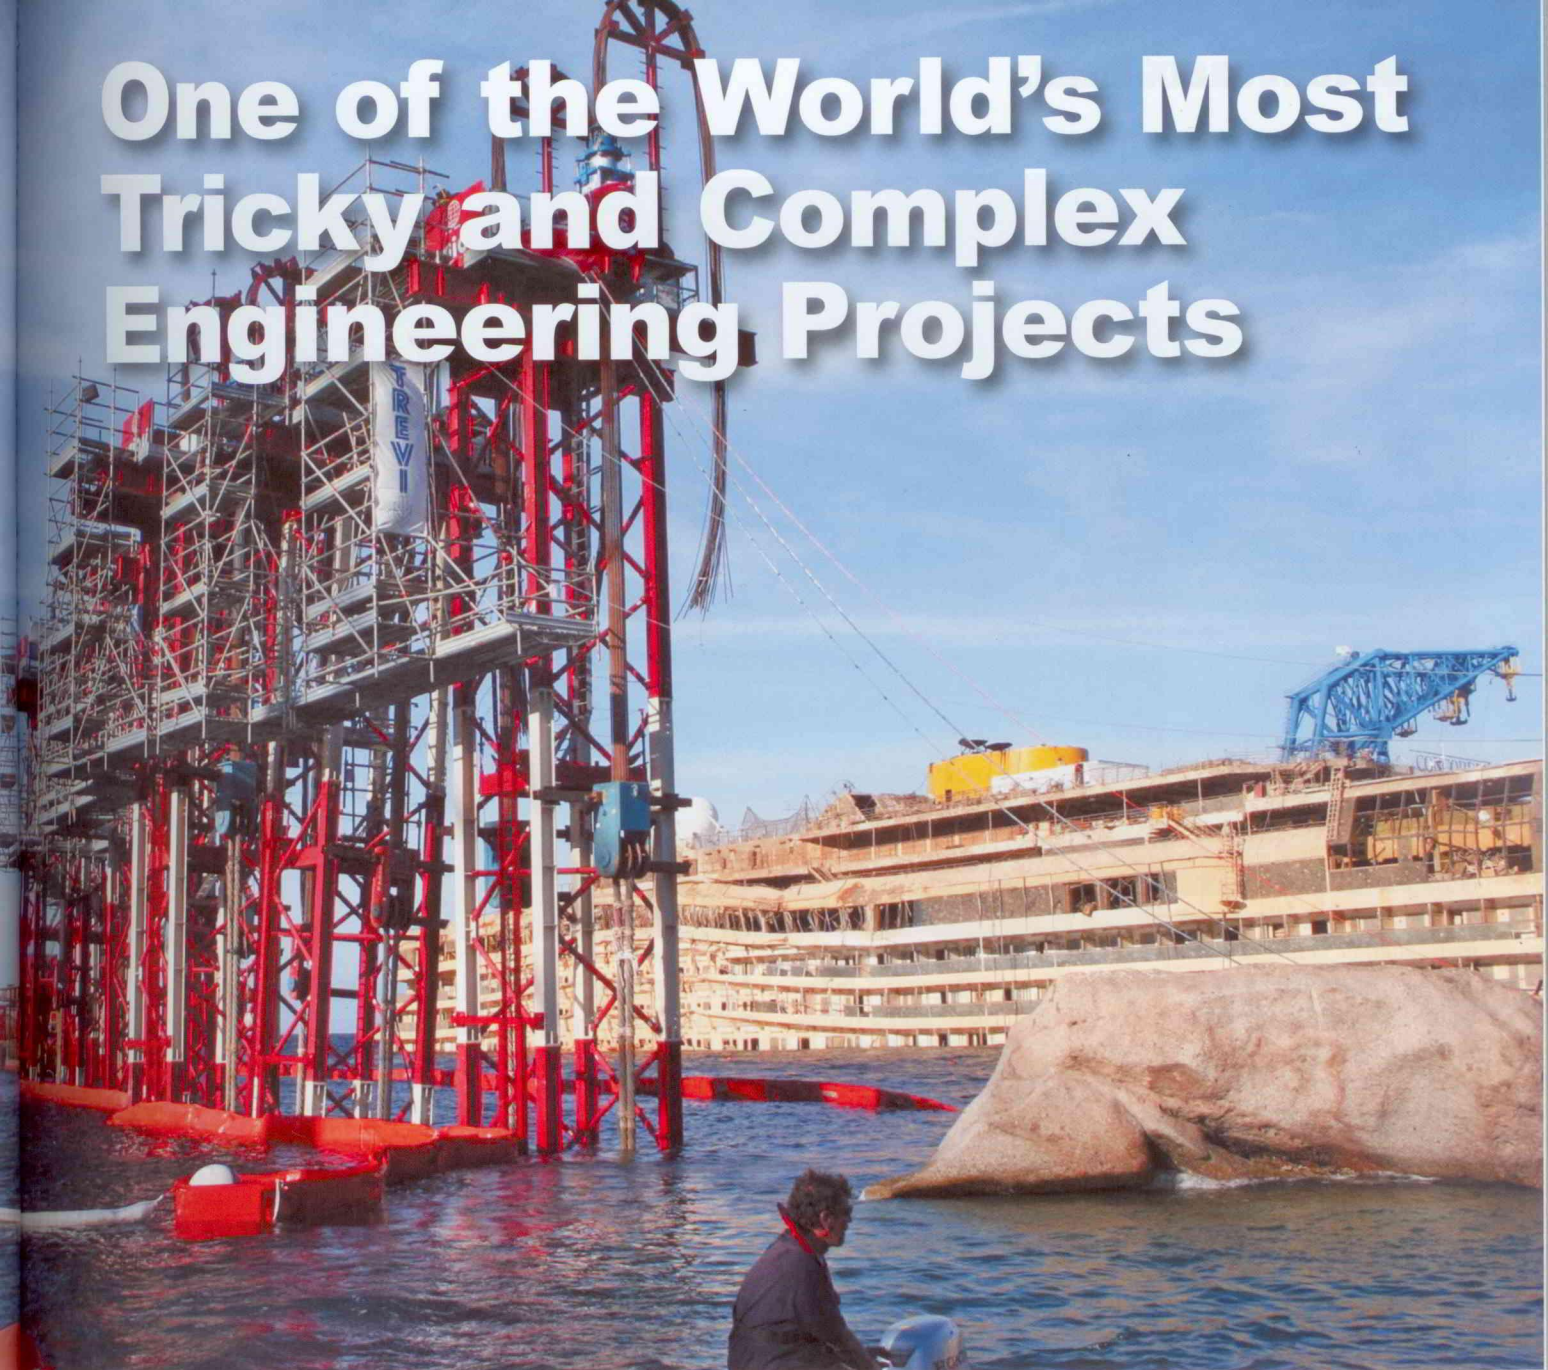
Strandjacks are mounted to the top of turrets that were constructed on the rock anchors. Chains attached to the strandjacks were passed under the hull and fixed to the port side of the wreck for balancing during rotation and parbuckling of the ship.

Titan-Micoperi divers attached two large steel cables to each of the anchor blocks, threaded them under the ship's hull and attached them to hydraulic jacks positioned on the outboard side of the ship for stabilization, finishing this portion of the project in November 2012. Next, Titan-Micoperi constructed seven additional anchor blocks to support cable towers and jacks for the subsequent parbuckling operation. Trevi's portion of the project wrapped up in July 2013.

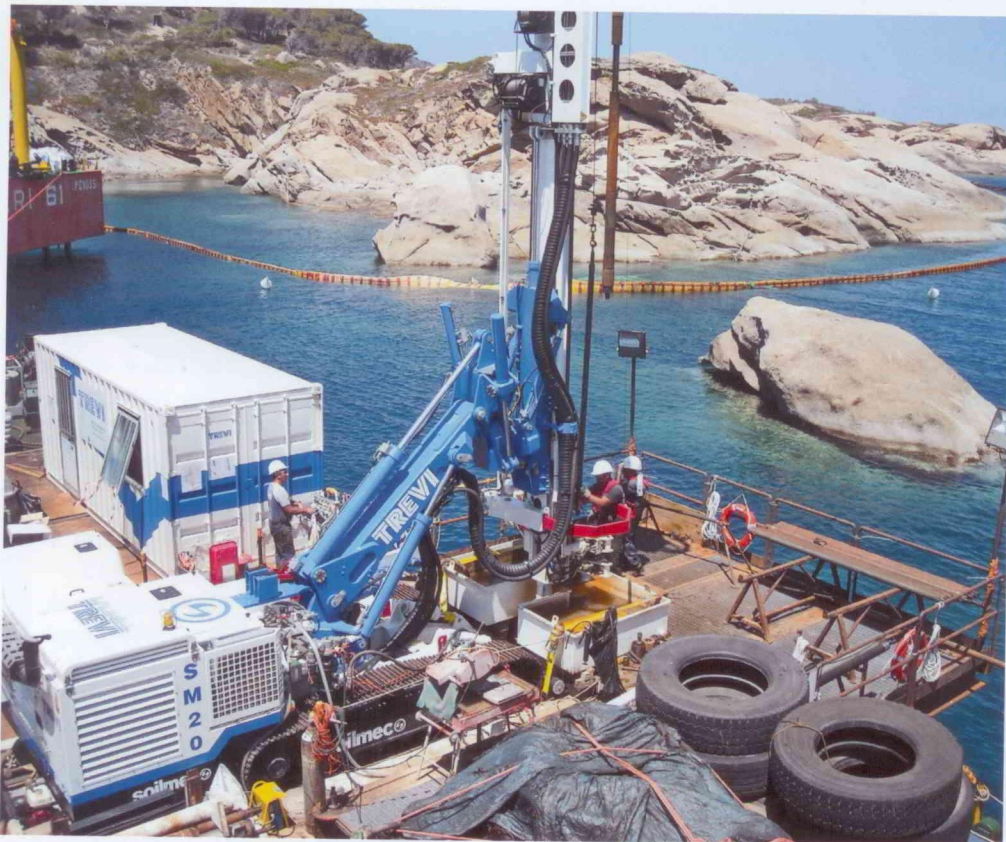
A Soilmec SM-20 microdrilling rig was used for the subsurface investigation into granitic rock.

Trevi conducted subsurface investigations along the perimeter of the wreck using simple corers and double core barrels to recover continuous sample cores. Crews conducted pressure meter tests to determine in-place strength parameters and performed video inspection to identify discontinuities within the rock.

The rocky seabed, with a slope of about 20 percent to 30 percent, subjected the long drilling set rods and casings to high bending stress. The survey exposed predominantly compact granite with loose-sand filled fractures that presented challenges during construction.

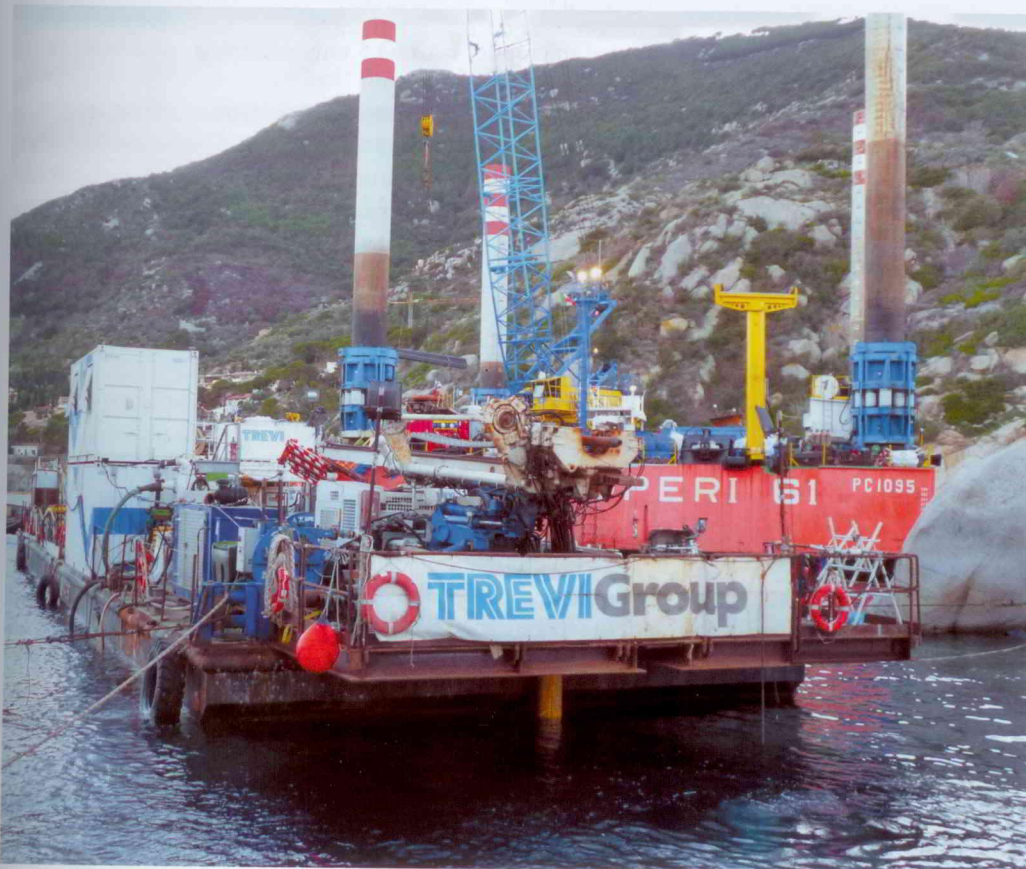
All work was conducted from barges directly off the shoreline.

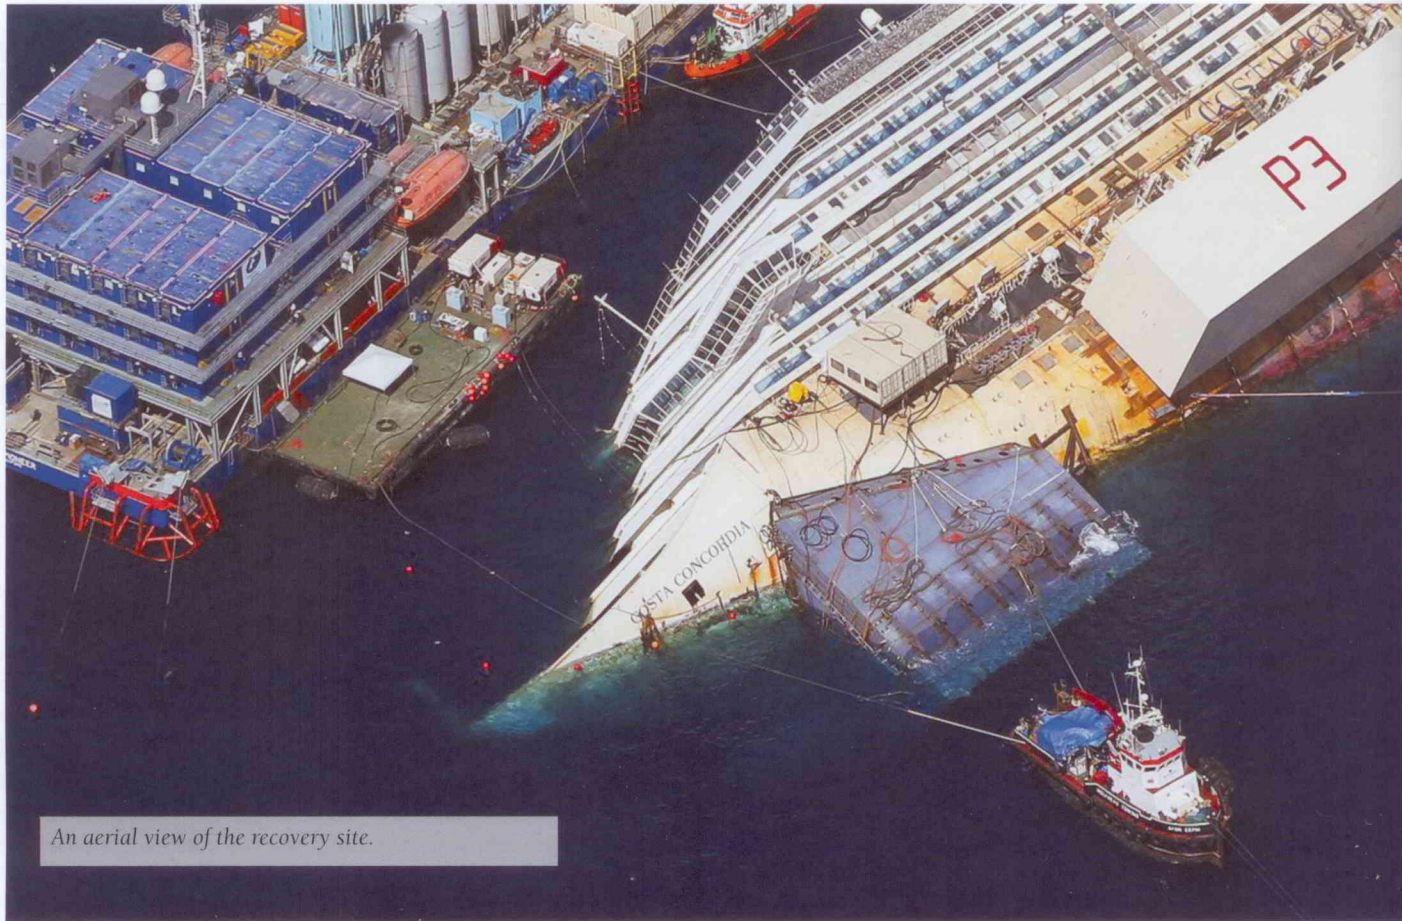
An aerial view of the recovery site.
